DEPARTMENT OF TRANSPORTATION**DIVISION OF ENGINEERING SERVICES**

Contract #: 04-0120F4Cty: SF/ALA Rte: 80 PM: 13.2/13.9File #: 69.28**WELDING INSPECTION REPORT****Resident Engineer:** Pursell, Gary**Address:** 333 Burma Road**City:** Oakland, CA 94607**Report No:** WIR-001010**Date Inspected:** 15-Dec-2007**Project Name:** SAS Superstructure**OSM Arrival Time:** 2200**Prime Contractor:** American Bridge/Fluor Enterprises, a JV**OSM Departure Time:** 730**Contractor:** Zhenhua Port Machinery Company, Ltd (ZPMC), Changxing Island **Location:** Shanghai, China**CWI Name:** Chen Xi**CWI Present:** Yes No**Inspected CWI report:** Yes No N/A**Rod Oven in Use:** Yes No N/A**Electrode to specification:** Yes No N/A**Weld Procedures Followed:** Yes No N/A**Qualified Welders:** Yes No N/A**Verified Joint Fit-up:** Yes No N/A**Approved Drawings:** Yes No N/A**Approved WPS:** Yes No N/A**Delayed / Cancelled:** Yes No N/A**Bridge No:** 34-0006**Component:** CalTrans mock up**Summary of Items Observed:**

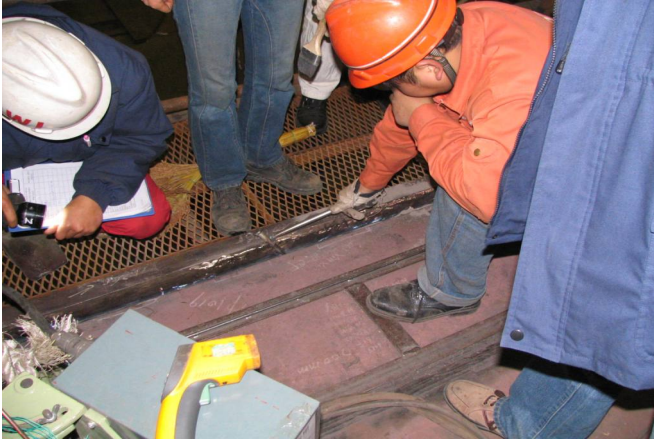
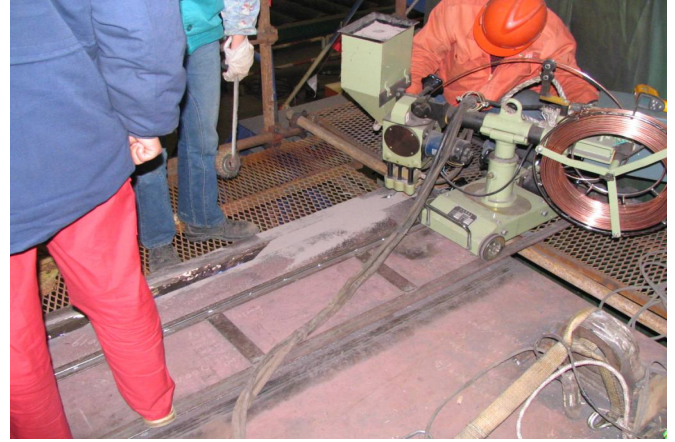
Caltrans QA Inspector observed Submerged arc welding (SAW) in progress of corner weld connection 2A. Upper shaft assembly MUC-MA106 skin plate C musc-ma112 to skin plate D musc-ma113. The weld joint is a Complete Joint Penetration (CJP), double bevel corner joint. The welder was observed welding fill passes in the 1G position using a chipping hammer and wire brushing to clean weld pass. The approved welder is identified as Mr. Yun Chuan Jin # 0503060 using approved welding procedure specification WPS-B-T-2221-C-U2b-S. Quality Control (QC) Inspector was observed measuring current welding parameters. Preheat and interpass temperatures were verified during welding activities and were within approved WPS minimum and maximum range. SAW welding consumable is verified and identified as EM12K JW3, 4.8mm diameter using JF-B flux. ZPMC QC Inspector Certified Welding Inspector (CWI) Mr. Chen Xi was observed monitoring welding activities at the workstation.
